BREAKWATER LOCATION
U. S. NAVAL AIR STATION, ALAMEDA, CALIFORNIA

MODEL INVESTIGATION

TECHNICAL MEMORANDUM NO. 2-242

DECEMBER 1947

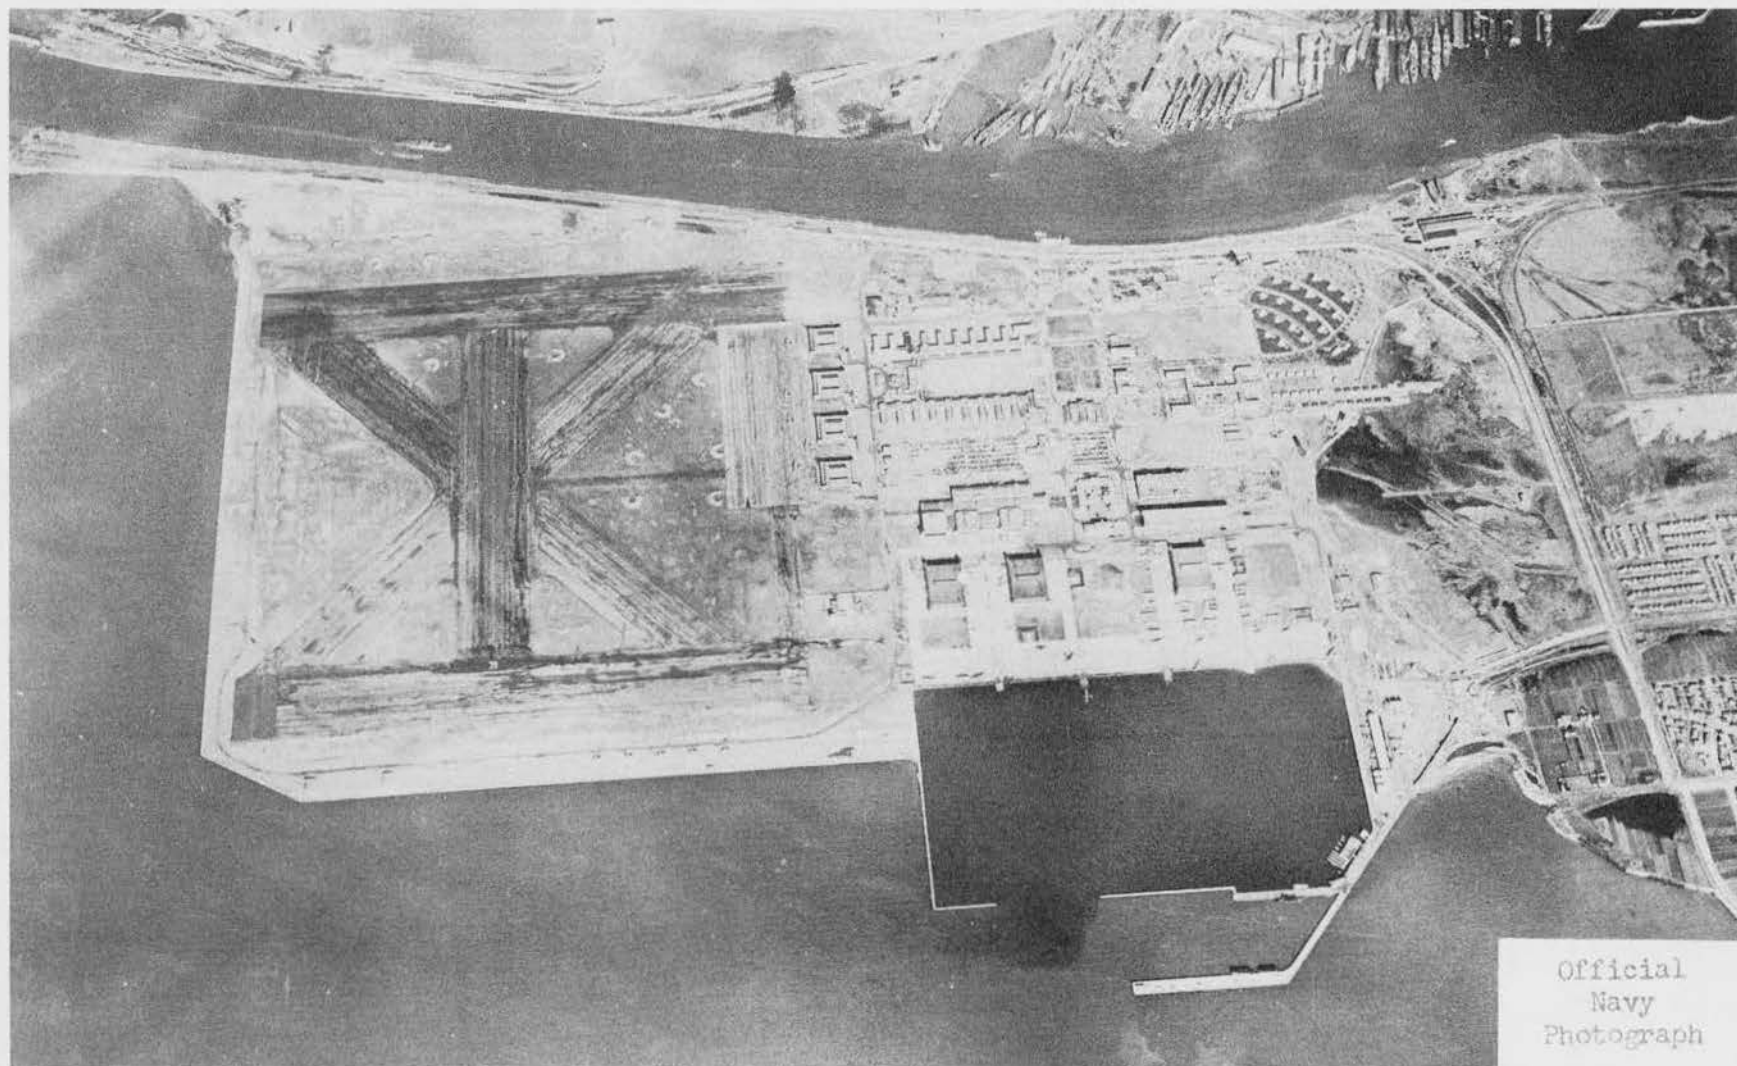
Official
Navy
Photograph

Aerial view of Alameda Naval Air Station, January 1942, looking north.
Seaplane lagoon and carrier pier in foreground.

mlw contour in the bay to a 2000-ft-radius turning basin. An aerial view of the Naval Air Station, showing conditions as of January 1942, is shown on the frontispiece.

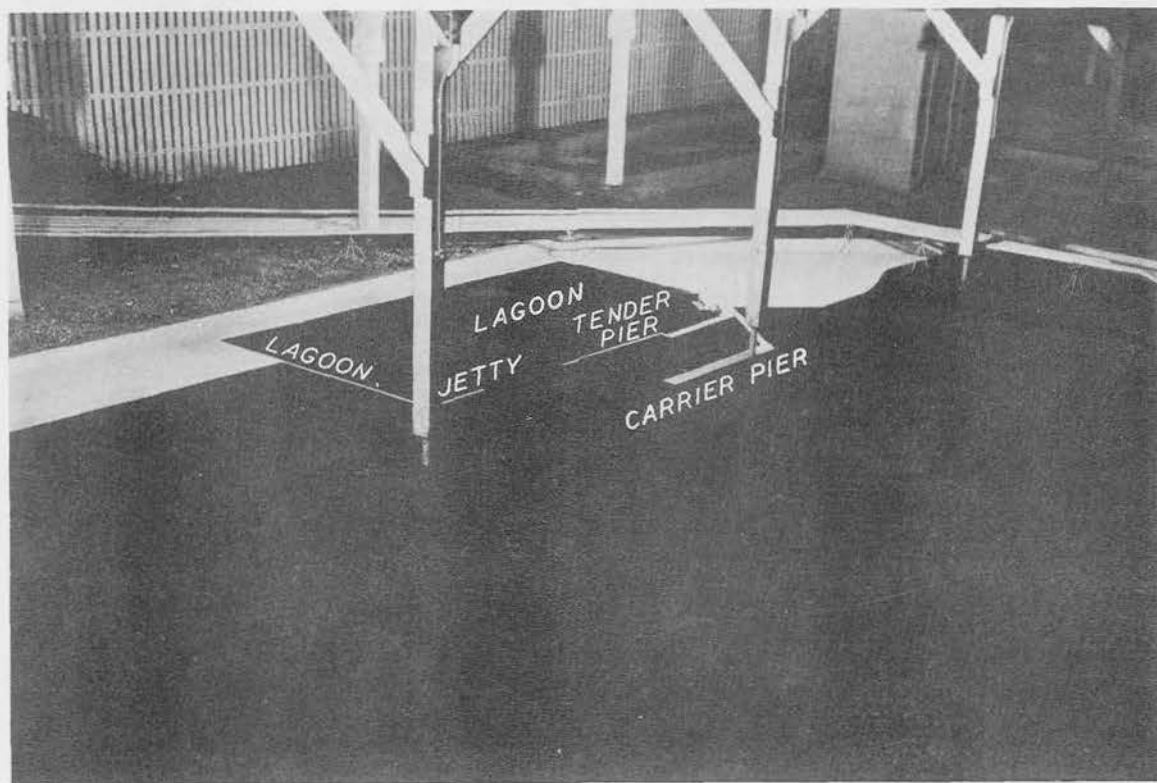
Fig. 2. General view of model representing conditions of March 1943

10. The model was of the fixed-bed type constructed to a linear-scale ratio of 1:200 (both vertical and horizontal scales). The corresponding time and velocity scales were 1:14.14. Reproduced in the model were the shore line adjacent to the Naval Air Station, the seaplane lagoon, the carrier pier, the turning basin and entrance channel, and a sufficient area of San Francisco Bay to permit accurate reproduction of prototype wave action and tidal currents in the problem area (see figures 1 and 2).

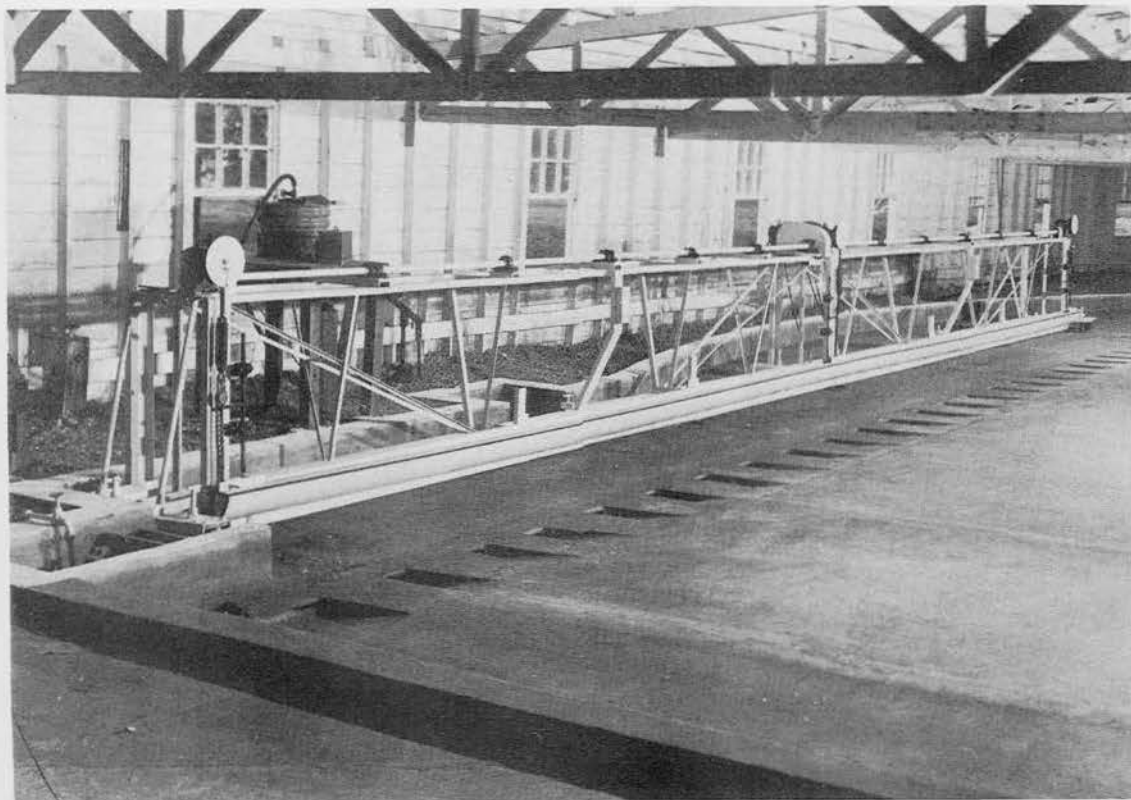
11. Prototype waves were reproduced to scale in the model by two plunger-type wave machines; figure 3 shows one of these machines. Generation of waves was accomplished by displacement of water caused by vertical movement of the plunger. Different combinations of the plunger stroke, speed, and submergence generated waves of desired characteristics. To simulate waves from different directions of approach, the wave machines were mounted on casters and placed in a circular pit in such manner that they could be moved to the proper position on the model for generating waves from the desired directions.

Fig. 3. Wave machine

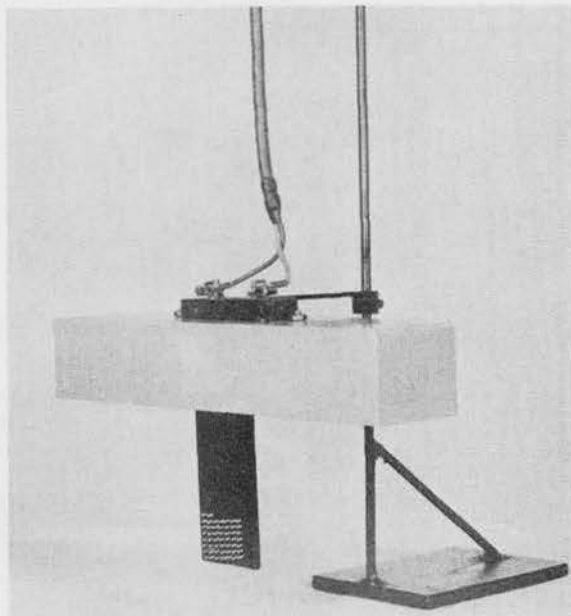
12. Wave heights in the model were measured with a device designed and constructed at the Experiment Station especially for this purpose. This wave-height measuring gage (figure 4) consisted of a resistance staff installed in a direct-current circuit in which the individual resistors were so arranged that the current through the circuits

Fig. 4
Wave-height measuring device

varied directly with the submergence of the staff in water. The gages were calibrated by varying the submergence of the staffs in still water and observing the corresponding current drain on a milliammeter. The external contacts of each gage were exposed along the face of the staff in 0.002-ft vertical increments (model). The gages, therefore, were capable of detecting vertical fluctuations of the water surface with an accuracy of 0.002 ft in the model, corresponding in this case to 0.4 ft prototype.

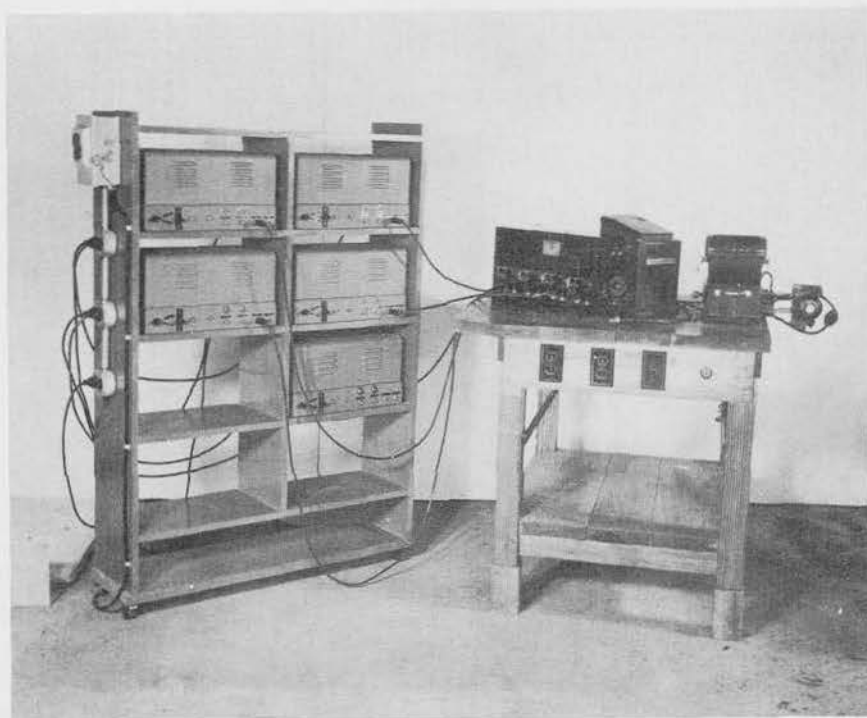
13. In order to record for measurement the rapid fluctuations of current in the gage staff circuit (which fluctuations correspond to wave heights in the model), the electrical leads from the gage staff were connected to a modified D'Arsonval galvanometer of a recording oscillograph

Fig. 5. Wave-height recording apparatus

(figure 5). The oscillograph contained seven of these modified D'Arsonval (moving coil) galvanometer units, each unit being so installed that its deflections, resulting from electrical current changes in the gage staff circuit, were transmitted as a beam of light to a strip of moving, sensitized, photographic recording paper. The resulting record or oscillogram was a two-dimensional graphic plot of model waves to a known scale, from which it was possible to measure wave heights.

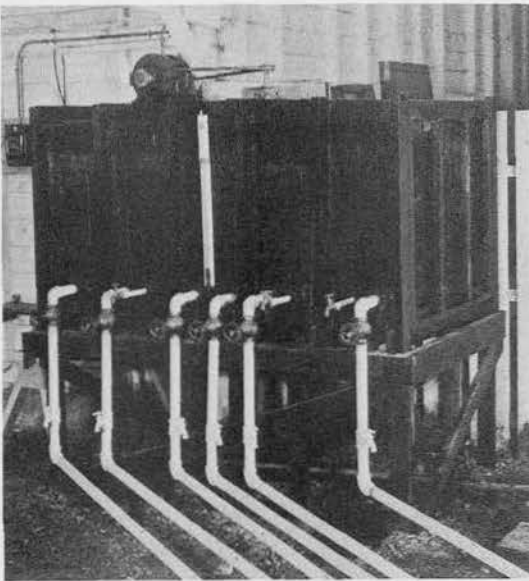
Fig. 7. Mixing tank

16. The shoaling apparatus consisted of a mixing tank and silt material injectors. The mixing tank was

equipped with a motor-driven propeller for agitating the water-gilsonite mixture during the model tests. Attached to this tank was a system of valves and pipes for distribution of the water-gilsonite mixture to the injectors. Troughs with triangular-shaped end sections and 1/8-in.-diameter holes spaced along the trough bottom assured an even distribution of the mixture into the model (see figures 6, 7, and 8).

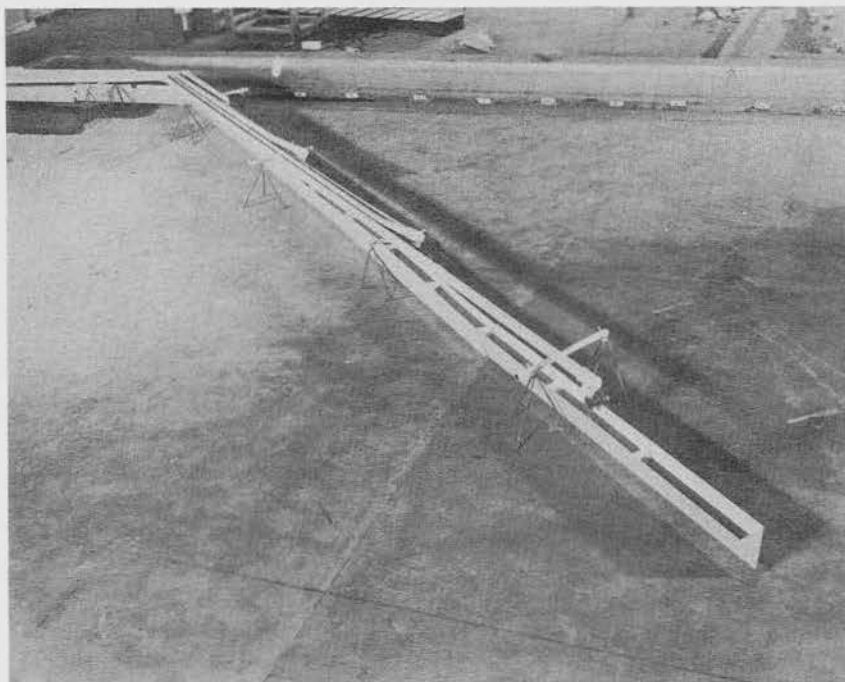
Fig. 8. Silt material injectors and header pit

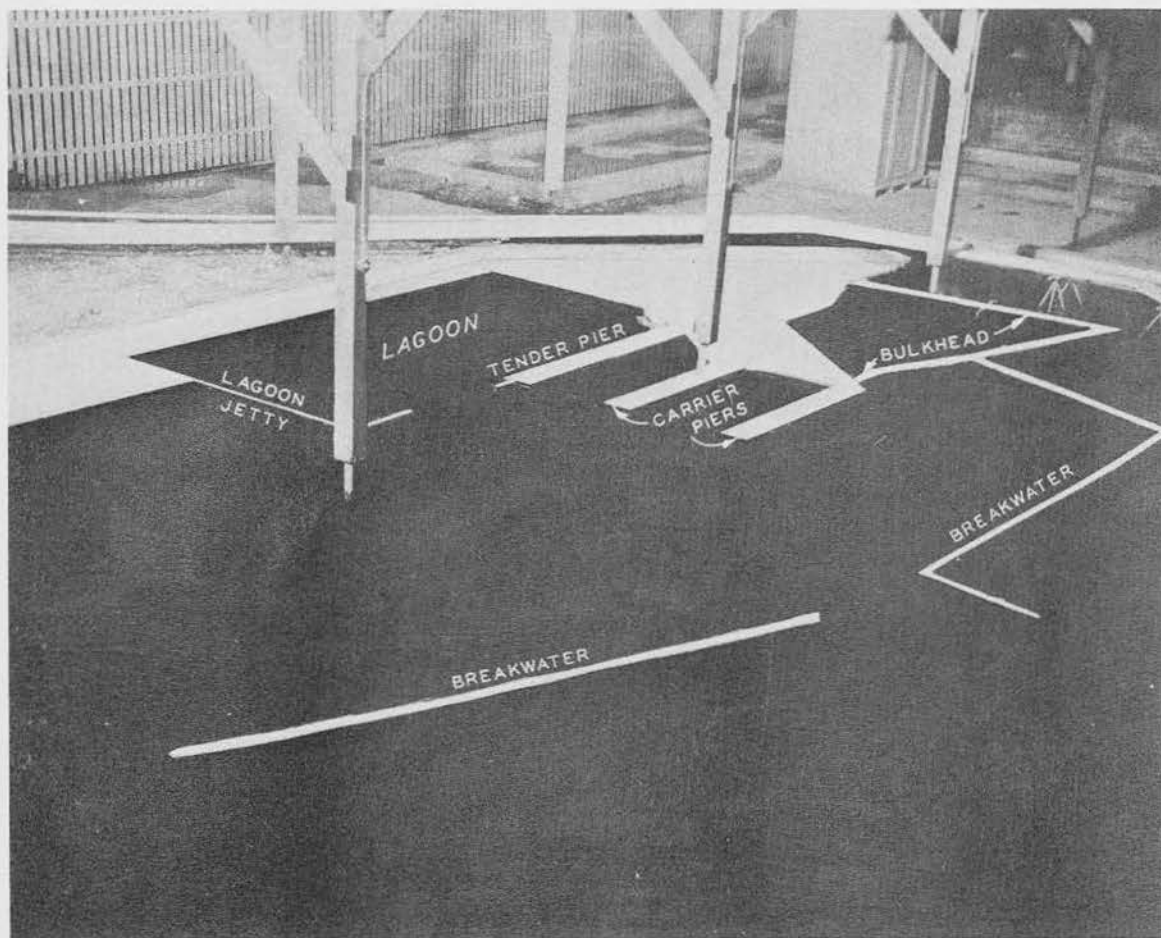
105. A plan very similar to plan 21A of this report was selected for construction in the prototype. Construction of the breakwater was begun in the latter part of 1945 and completed in April 1947.

Fig. 9. General view of model with plan 21A installed

On the basis of the findings of the model investigation and practical considerations relating to the problem at the Alameda Naval Air Station, a plan designated in this report as plan 21A ^(Plate 72) was recommended for construction in the prototype. This plan consisted principally of a 6830-ft rubble-mound breakwater located immediately south of the turning basin and aligned to enclose the turning basin except for the entrance channel on the west and a 750-ft navigation opening on the south.

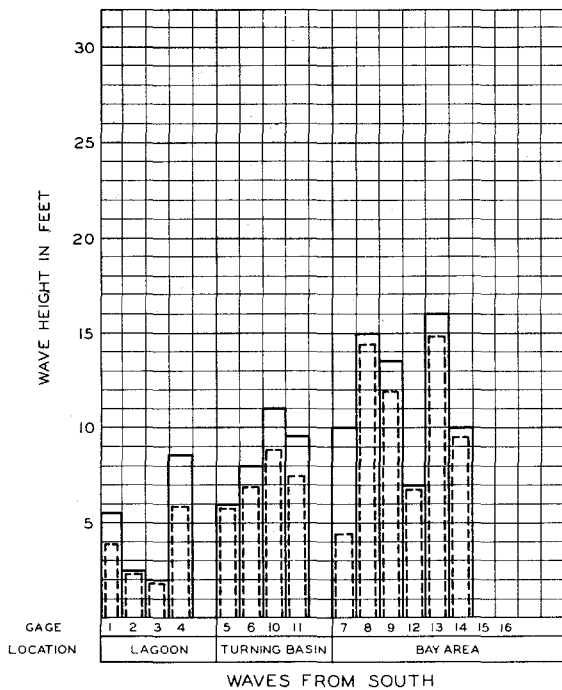
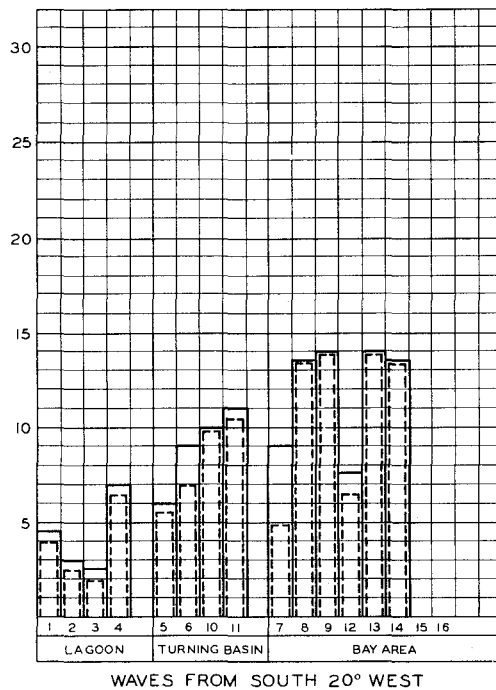
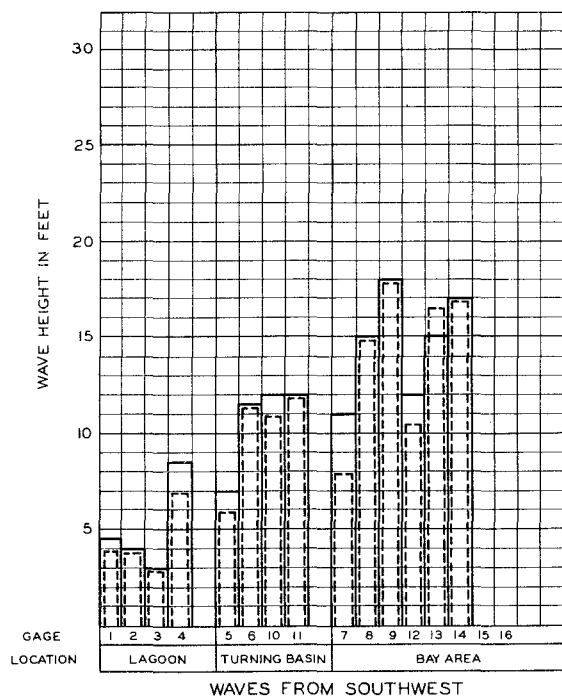
MODEL STUDY OF BREAKWATER LOCATION
U.S. NAVAL AIR STATION
ALAMEDA, CALIFORNIA

COMPARISON OF WAVE HEIGHTS
BASE TEST AND PLAN I

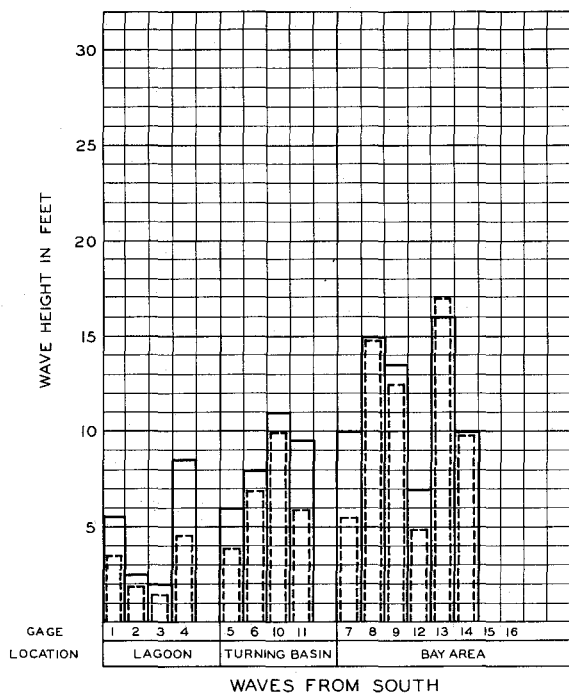
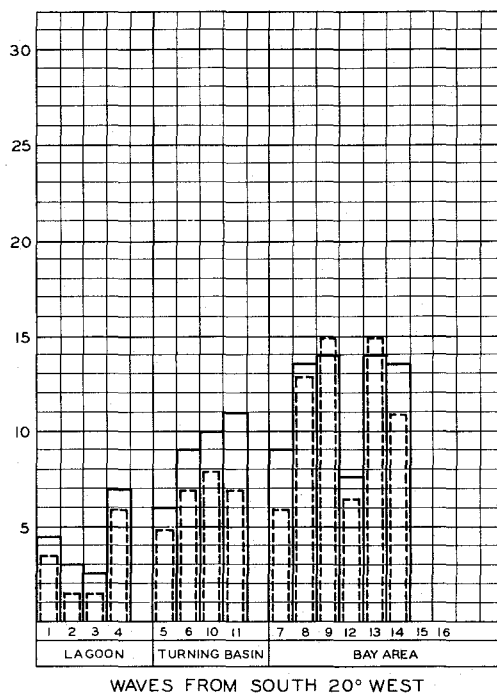
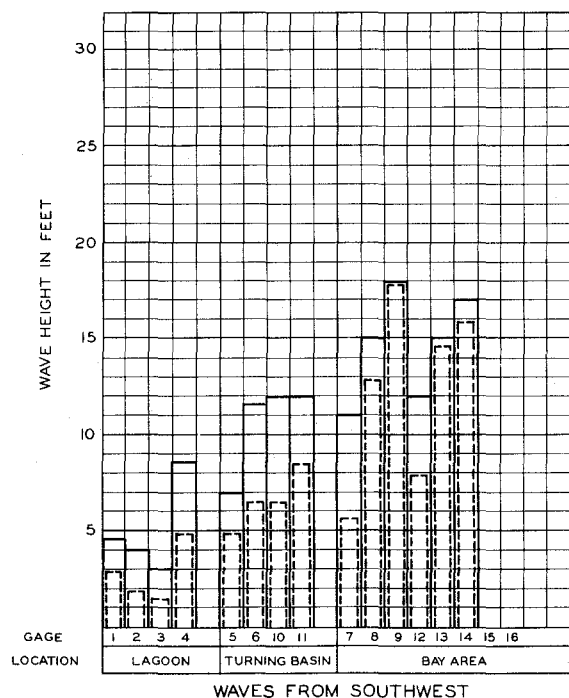
MODEL STUDY OF BREAKWATER LOCATION
U.S. NAVAL AIR STATION
ALAMEDA, CALIFORNIA

COMPARISON OF WAVE HEIGHTS
BASE TEST AND PLAN 2

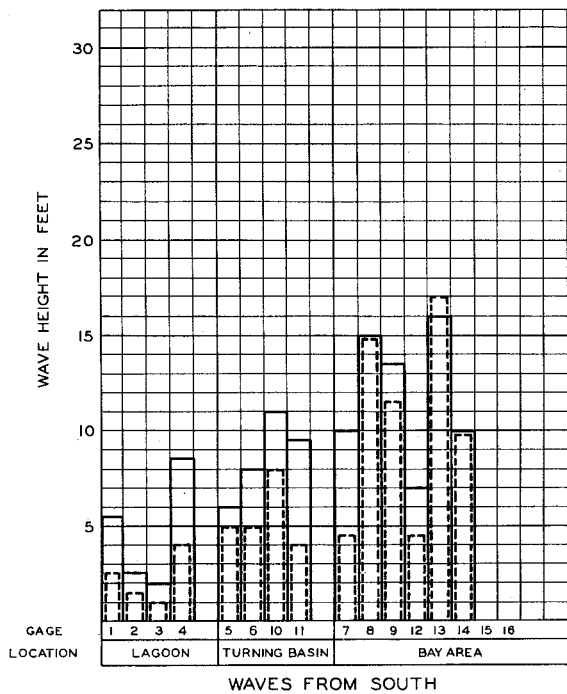
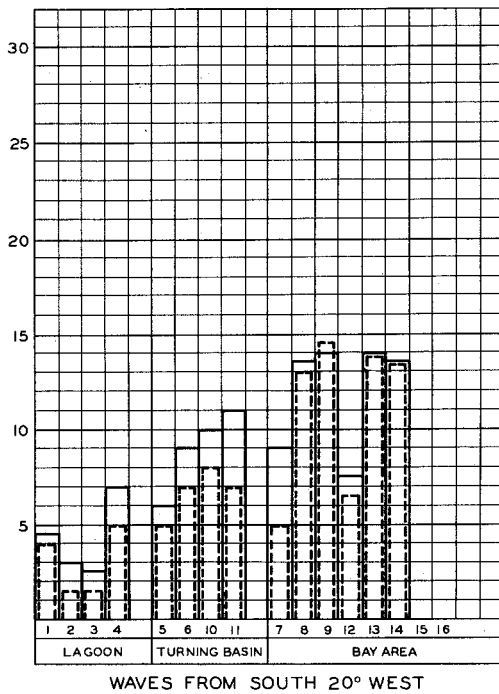
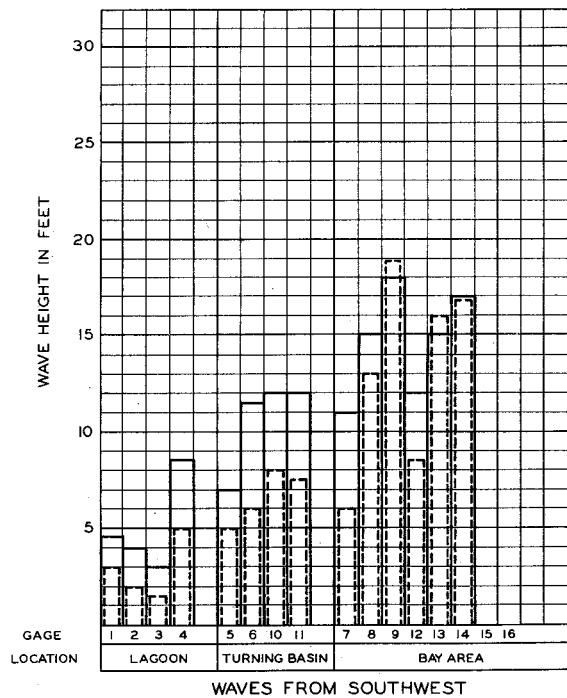
MODEL STUDY OF BREAKWATER LOCATION
U.S. NAVAL AIR STATION
ALAMEDA, CALIFORNIA

COMPARISON OF WAVE HEIGHTS
BASE TEST AND PLAN 2A

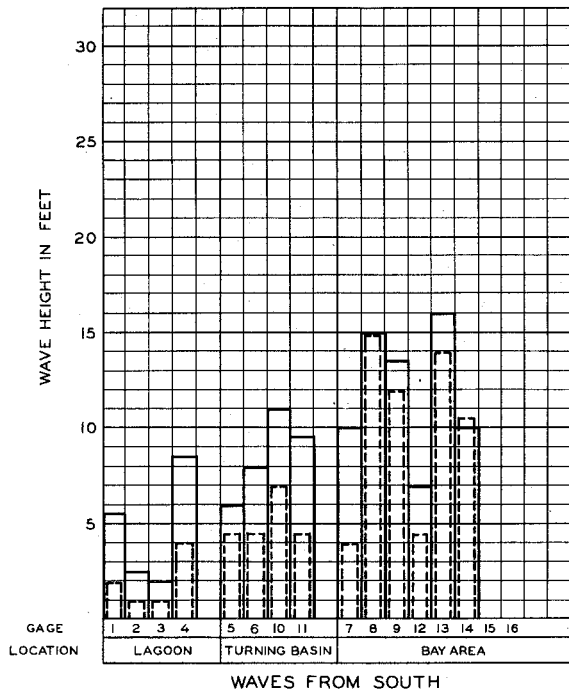
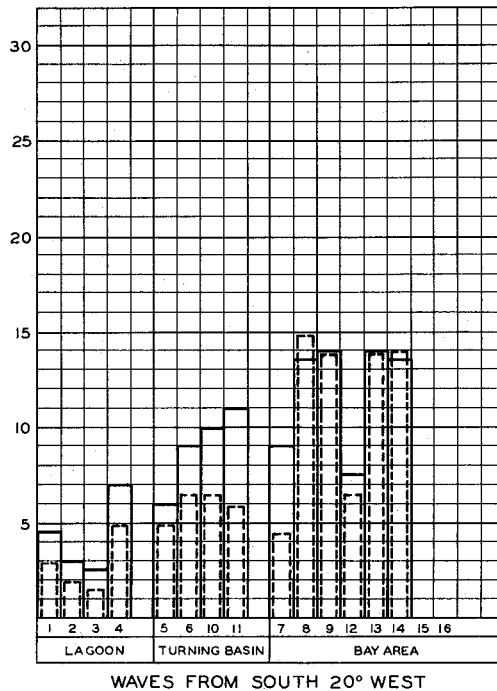
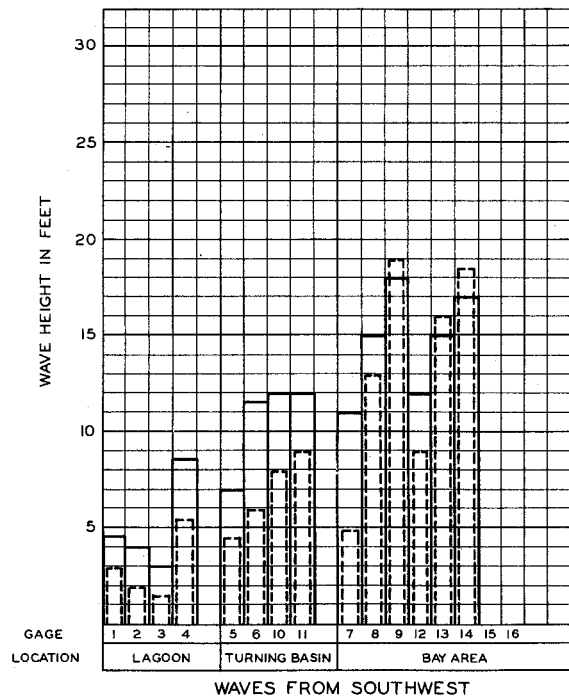
MODEL STUDY OF BREAKWATER LOCATION
U. S. NAVAL AIR STATION
ALAMEDA, CALIFORNIA

COMPARISON OF WAVE HEIGHTS
BASE TEST AND PLAN 2 B

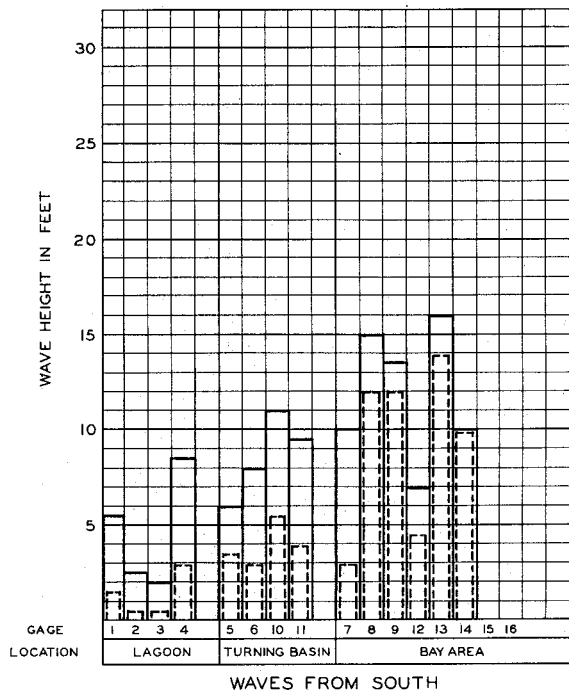
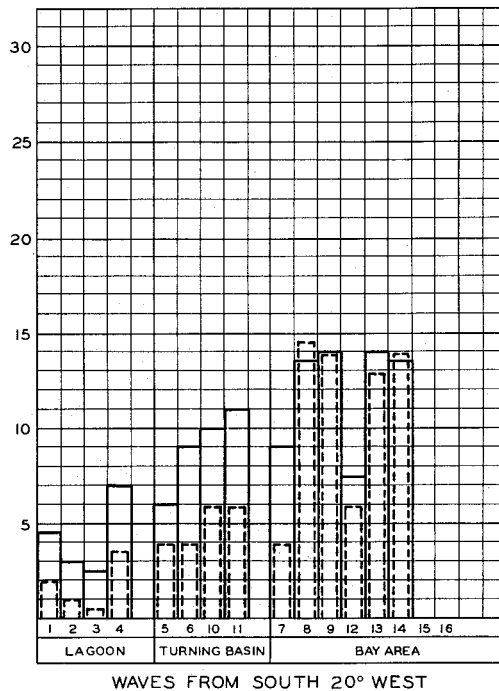
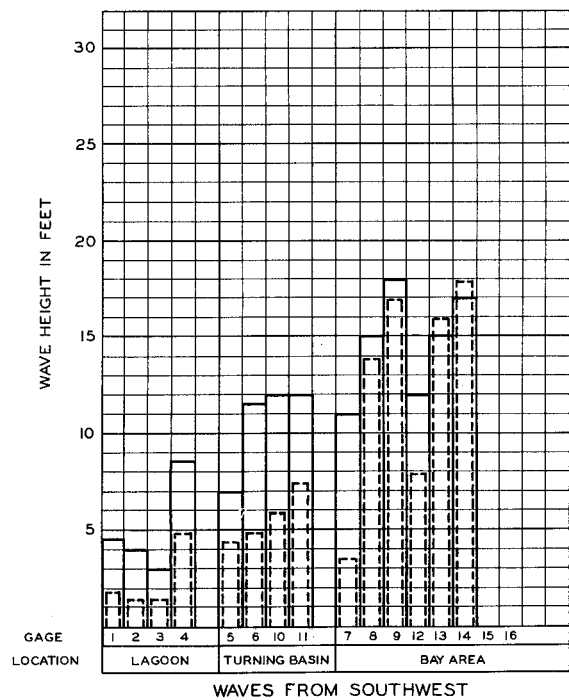
MODEL STUDY OF BREAKWATER LOCATION
U.S. NAVAL AIR STATION
ALAMEDA, CALIFORNIA

COMPARISON OF WAVE HEIGHTS
BASE TEST AND PLAN 2C

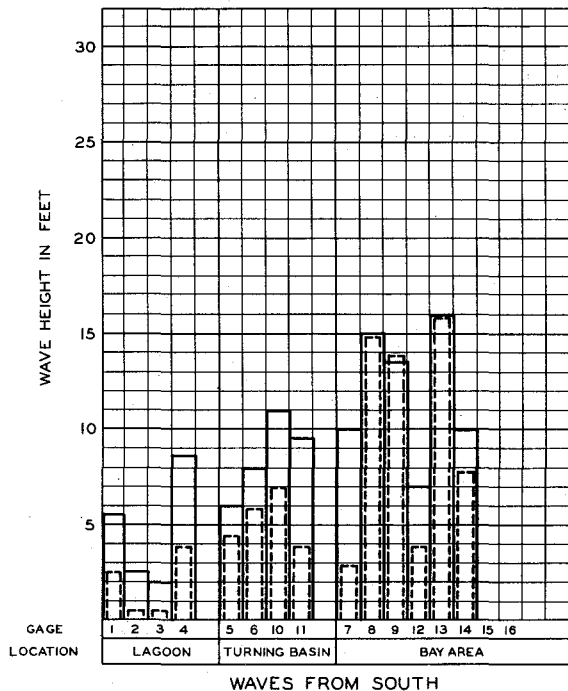
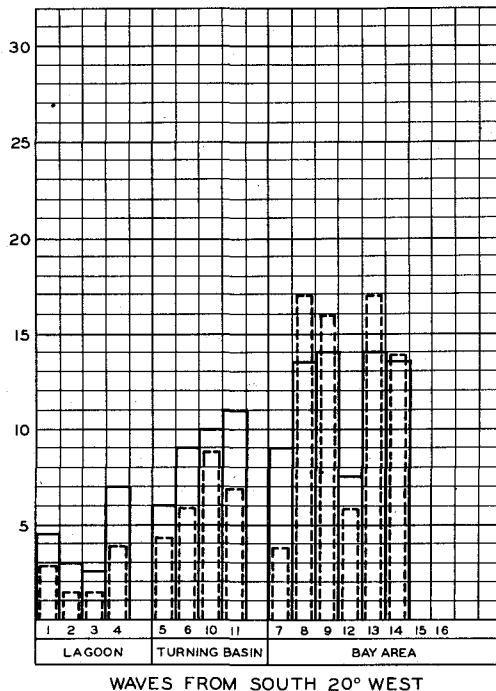
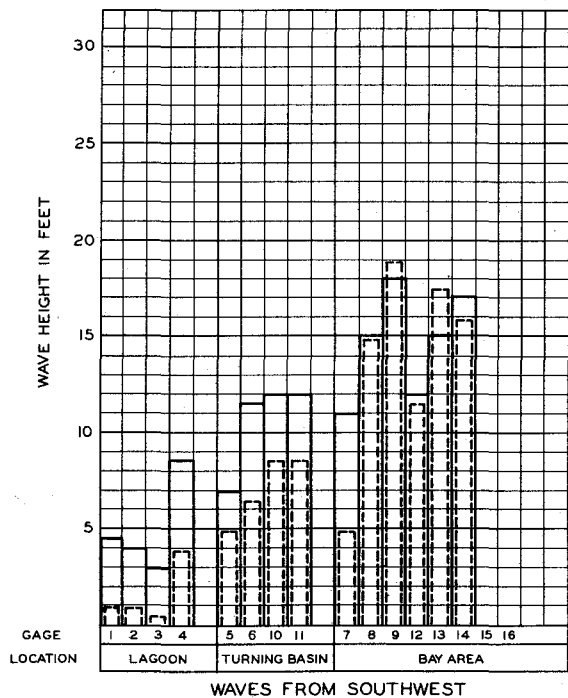
MODEL STUDY OF BREAKWATER LOCATION
U. S. NAVAL AIR STATION
ALAMEDA, CALIFORNIA

COMPARISON OF WAVE HEIGHTS
BASE TEST AND PLAN 4

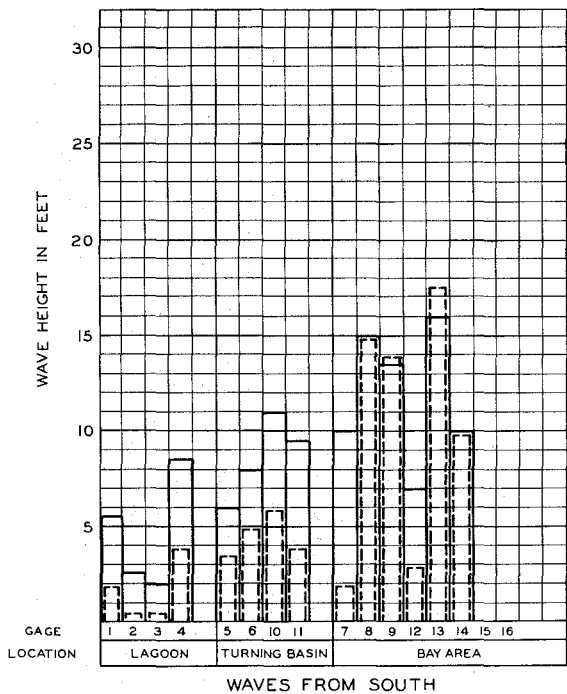
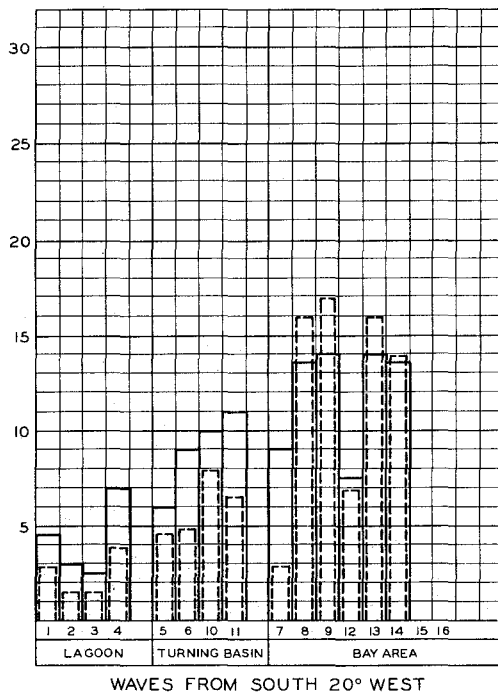
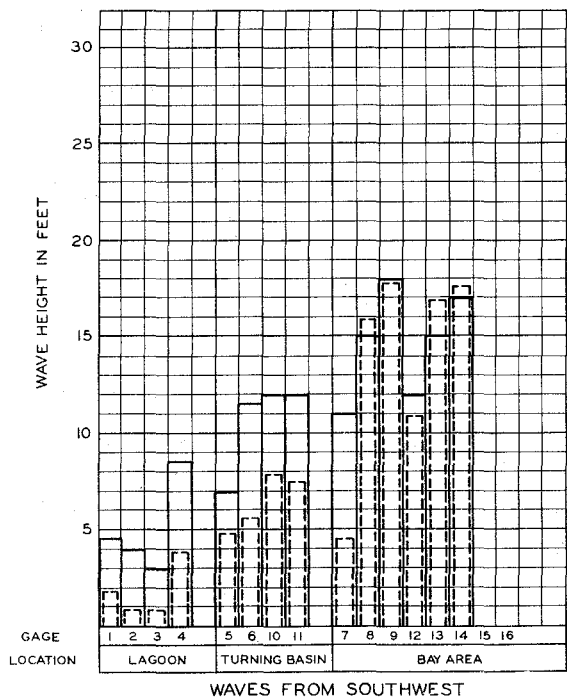
MODEL STUDY OF BREAKWATER LOCATION
U.S. NAVAL AIR STATION
ALAMEDA, CALIFORNIA

COMPARISON OF WAVE HEIGHTS
BASE TEST AND PLAN 4A

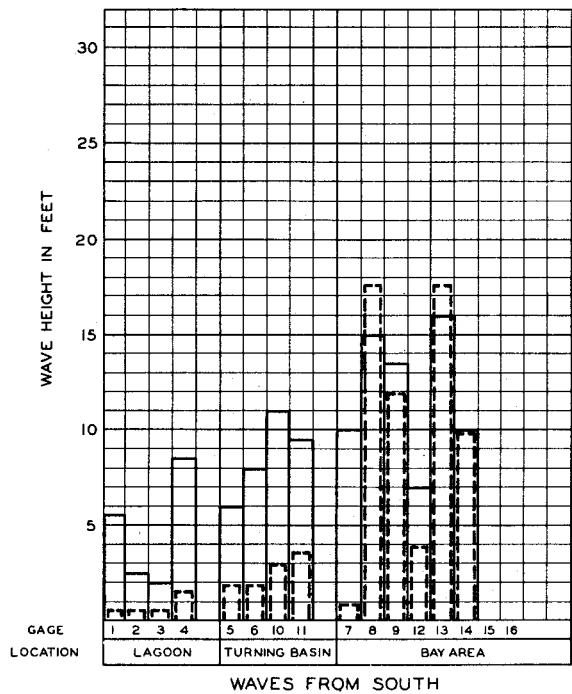
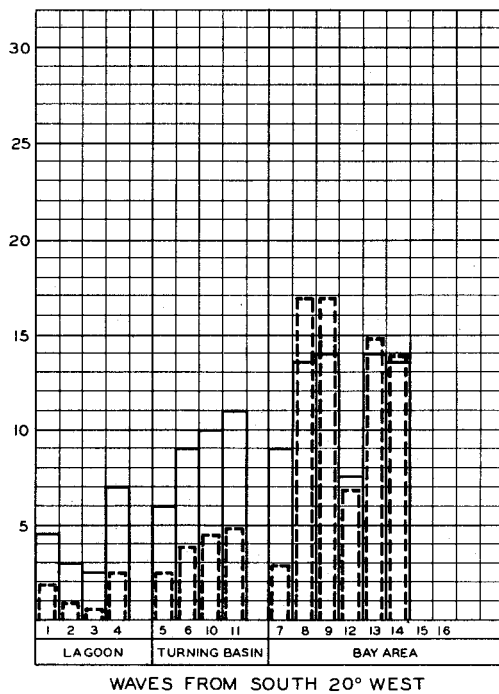
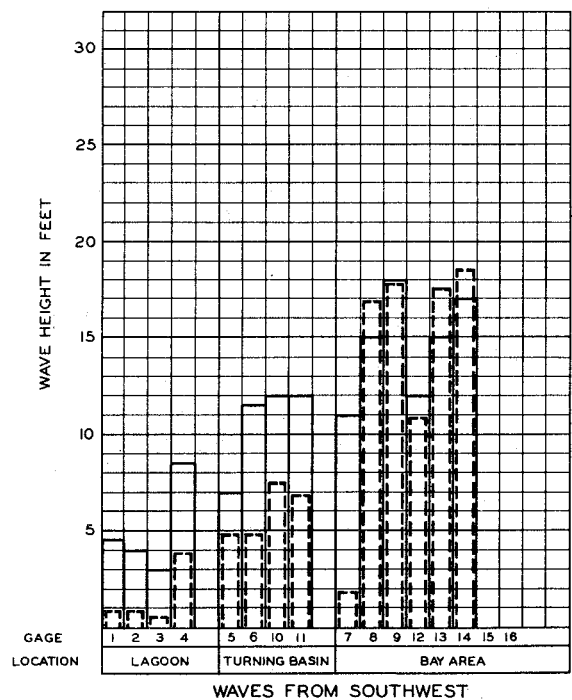
MODEL STUDY OF BREAKWATER LOCATION
U. S. NAVAL AIR STATION
ALAMEDA, CALIFORNIA

COMPARISON OF WAVE HEIGHTS
BASE TEST AND PLAN 4B

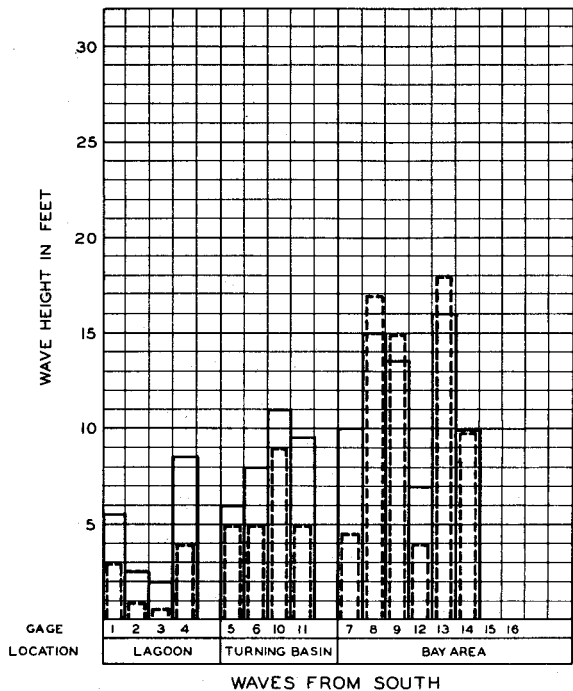
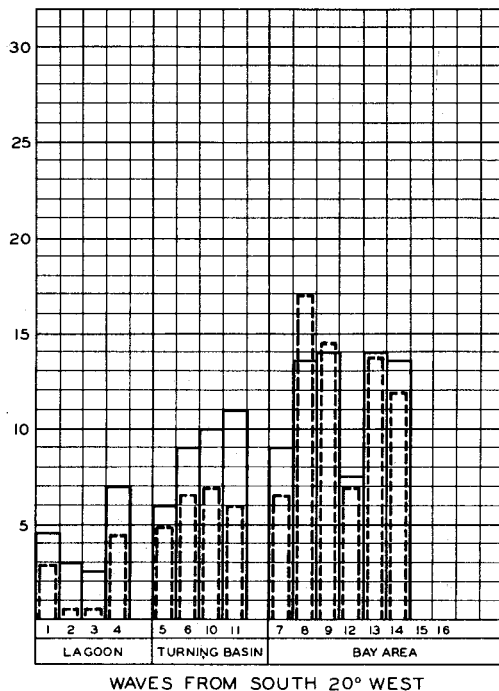
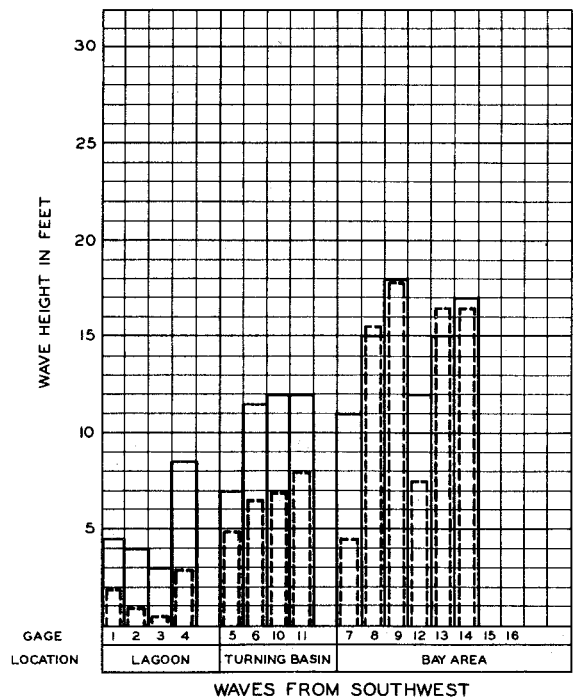
MODEL STUDY OF BREAKWATER LOCATION
U.S. NAVAL AIR STATION
ALAMEDA, CALIFORNIA

COMPARISON OF WAVE HEIGHTS
BASE TEST AND PLAN 4C

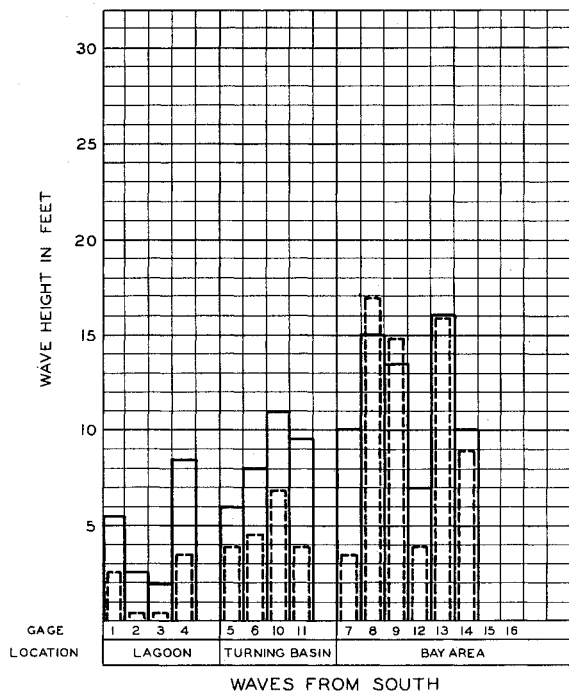
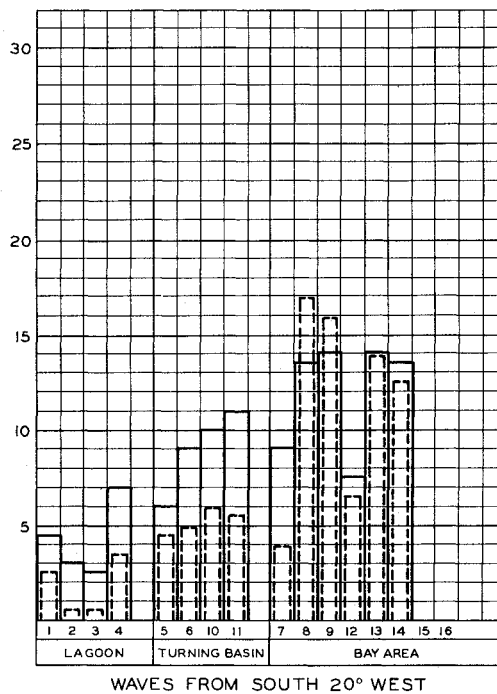
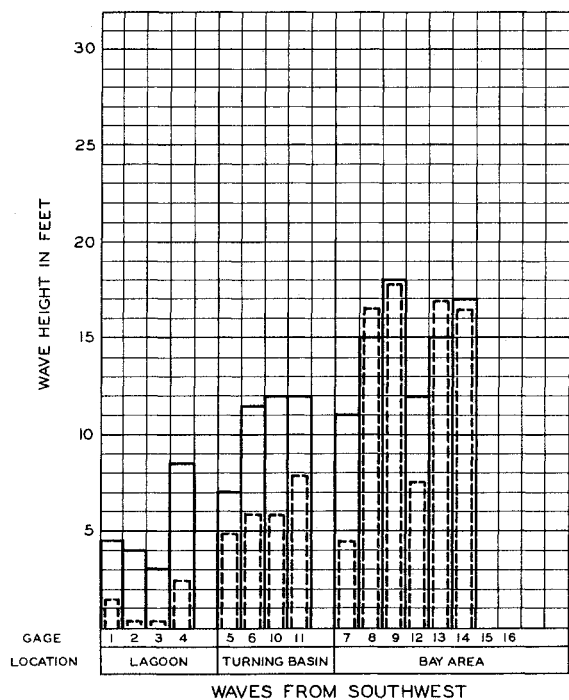
MODEL STUDY OF BREAKWATER LOCATION
U.S. NAVAL AIR STATION
ALAMEDA, CALIFORNIA

COMPARISON OF WAVE HEIGHTS
BASE TEST AND PLAN 5

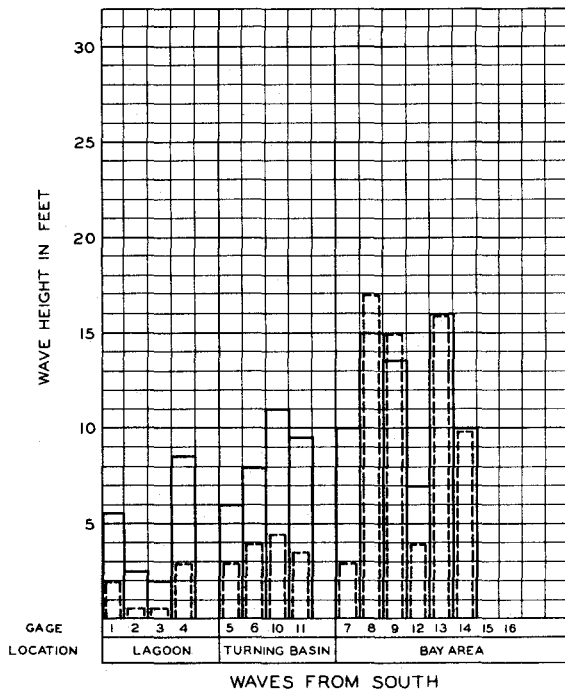
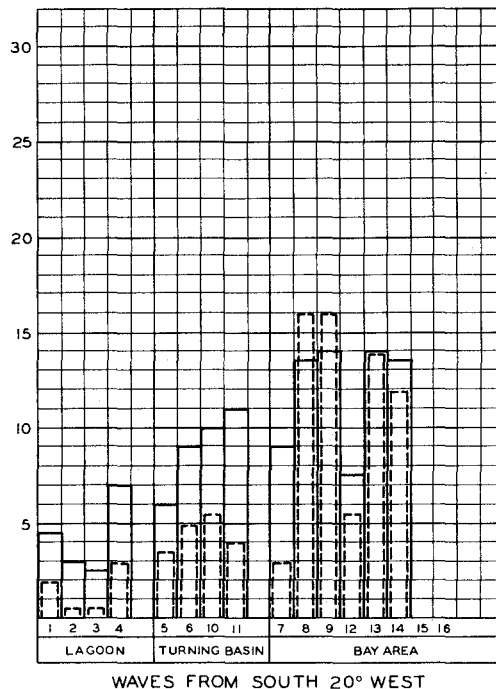
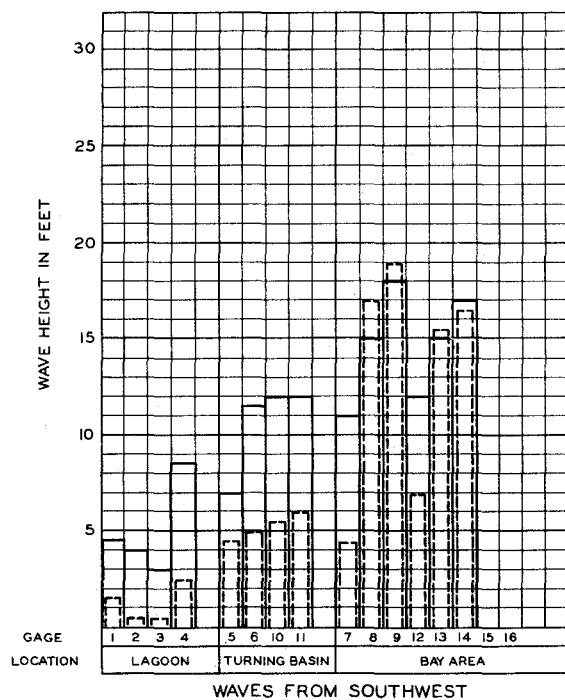
MODEL STUDY OF BREAKWATER LOCATION
U.S. NAVAL AIR STATION
ALAMEDA, CALIFORNIA

COMPARISON OF WAVE HEIGHTS
BASE TEST AND PLAN 5A

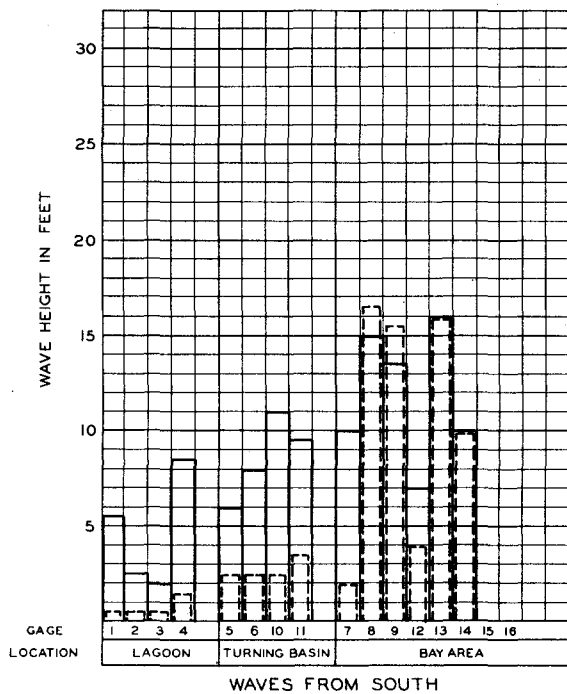
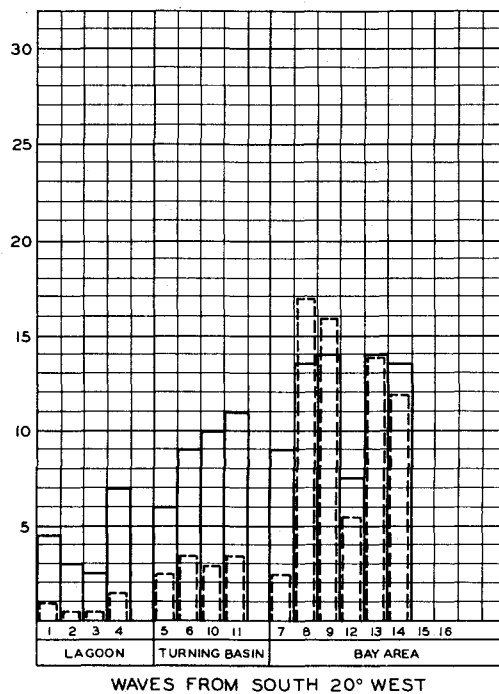
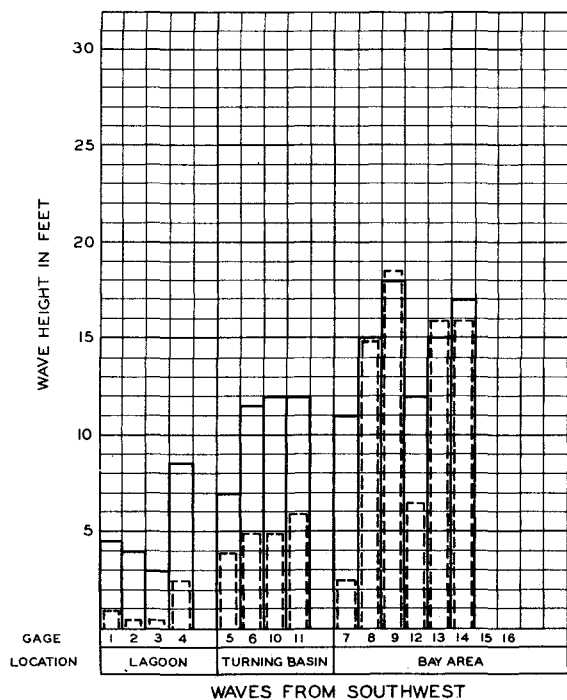
MODEL STUDY OF BREAKWATER LOCATION
U. S. NAVAL AIR STATION
ALAMEDA, CALIFORNIA

COMPARISON OF WAVE HEIGHTS
BASE TEST AND PLAN 5B

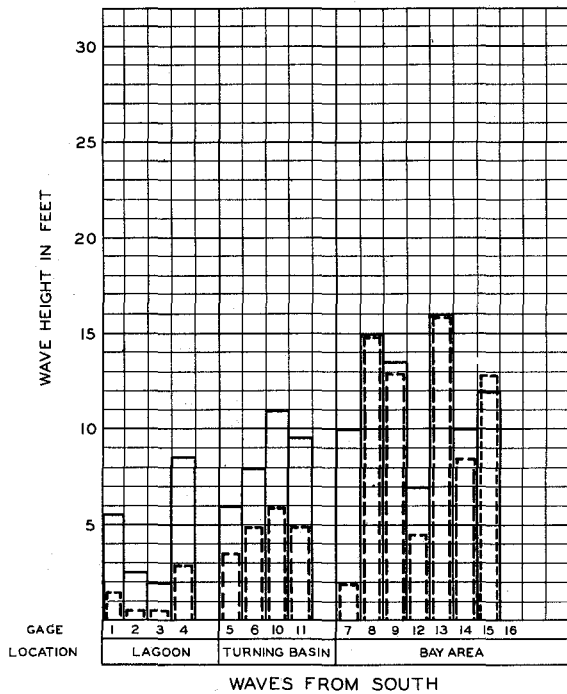
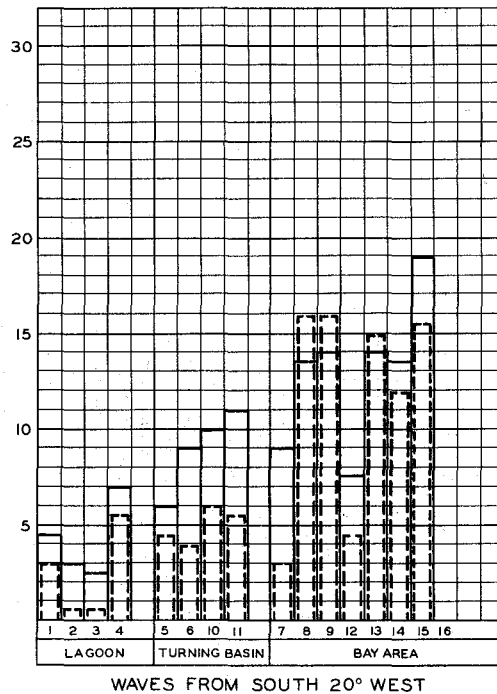
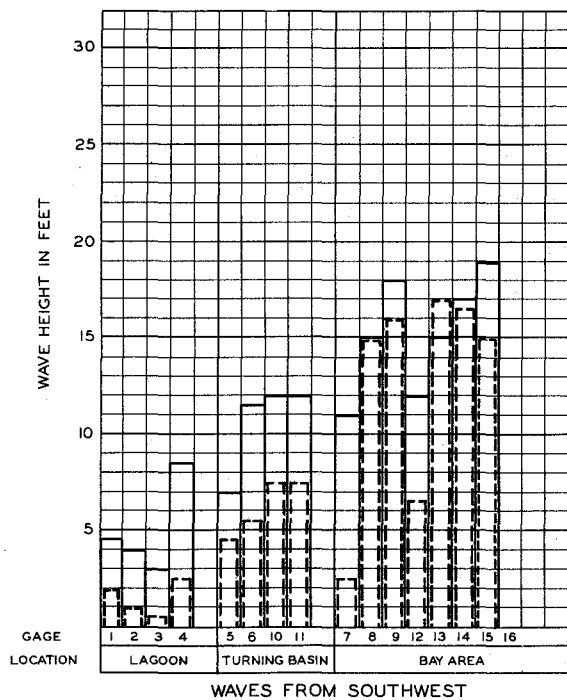
MODEL STUDY OF BREAKWATER LOCATION
U.S. NAVAL AIR STATION
ALAMEDA, CALIFORNIA

COMPARISON OF WAVE HEIGHTS
BASE TEST AND PLAN 5C
